Manhole Inspection Summary

Manhole # S29M1_005MH

Insp Date: **3/12/08 2:06 PM**

Location Address: **2829 Joseph Ave.**

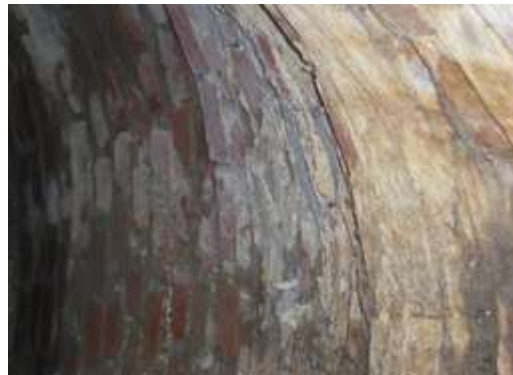
Defect 2

Infiltration: ☐ None ☐ Joint ☐ Cracks ☐ Mortar ☐ Roots ☒ **Wall**

Wall

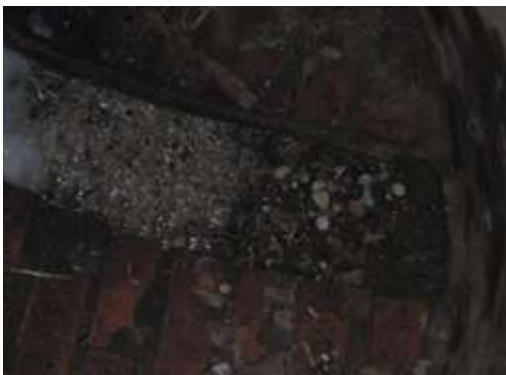
Defect 1

Condition: ☐ Sound ☐ Cracked ☐ Root Intrusion ☐ Deteriorated ☐ Leaks ☒ **Debris**

Channel

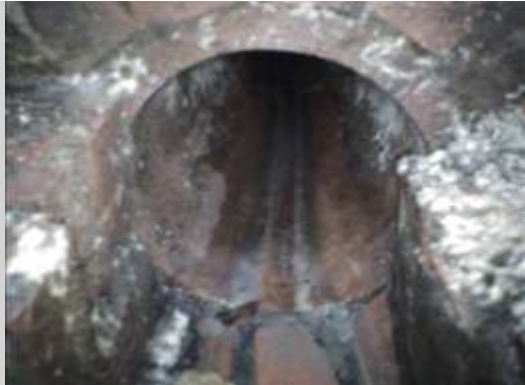
12 O'Clock Outflow

8 in. Circular Gravity Sewer
Pipe Out @ 12 O'Clock

Pipe Height: **10.8** (in.) Rod and Bar (Angled)
Pipe Material: **Clay** ☐ Pipe Lined
Invert Depth: **8.81** (ft.) Flow Characteristics: **Fast**
Deposits: ☒ None ☐ Mud ☐ Sludge ☐ Debris ☐ Grease
Silt Depth: (in.) Deposits Extent:
Infiltration: **None** Pipe Seal Cond: **Sound**

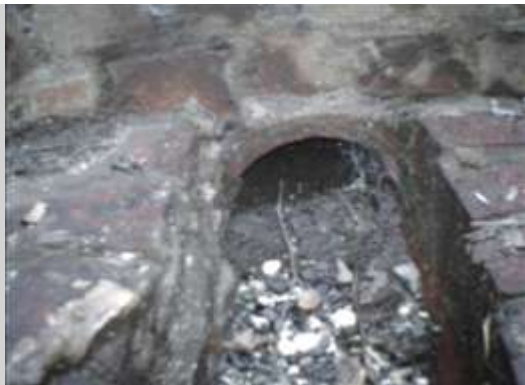
4 O'Clock Inflow

6 in. Circular Service Sewer
Pipe In @ 4 O'Clock

Pipe Height: **6** (in.) Rod and Bar (Angled)
Pipe Material: **Clay** ☐ Pipe Lined
Invert Depth: **8.44** (ft.) Flow Characteristics: **None**
Deposits: ☐ None ☐ Mud ☐ Sludge ☒ **Debris** ☐ Grease
Silt Depth: **3** (in.) Deposits Extent: **Heavy**
Infiltration: **None** Pipe Seal Cond: **Sound**

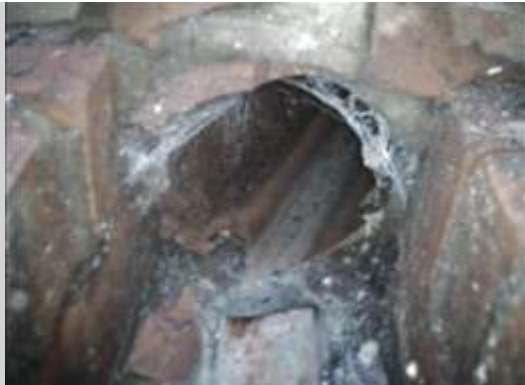
8 O'Clock Inflow

6 in. Circular Service Sewer
Pipe In @ 8 O'Clock

Pipe Seal Cond: **Broken**
